CALIFORNIA GEOLOGICAL SURVEY  
FAULT EVALUATION REPORT FER-246

**LAVIC LAKE, BULLION AND RELATED FAULTS**  
San Bernardino County, California

by  
Jerome A. Treiman  
November 19, 2002

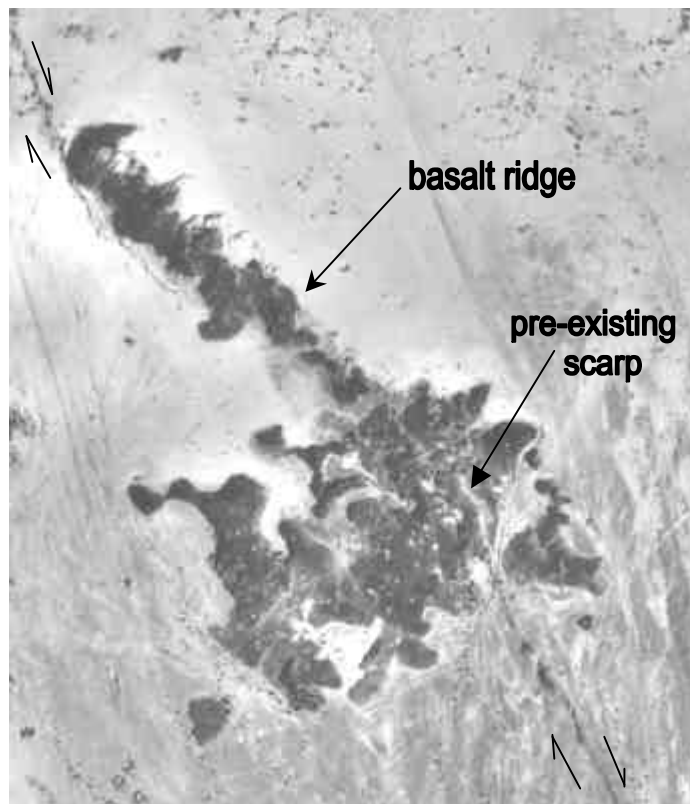
North of the Bullion Mountains the fault had extremely limited pre-earthquake expression (in aerial photos), mostly recognizable only in hindsight, although a scarp and parallel trough across a Pleistocene lava flow (from Sunshine crater) and adjacent pressure ridge at Lavic Lake provided evidence for Quaternary, but not necessarily Holocene, movement (locality 4d and Photo 1).

Photo 1 - outlier of Sunshine Peak basalt with prominent northwest-trending pressure ridge or ridge of extruded basalt (*from photo by I.K. Curtis, 1999 - leg 7, frame 5*).
